What's Beane Happening?

The newsletter of The River Beane Restoration Association
Issue No 30 Spring 2021

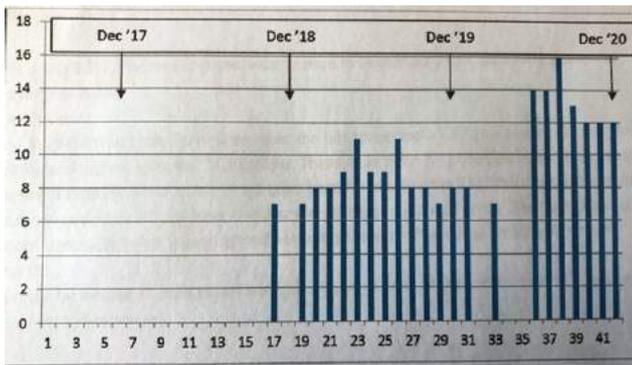
Woodhall Estate results Nov. 2018 – Dec. 2020

The charts below show the riverfly scores from our sample sites on the Woodhall Estate in the first new bypass channel, and by Stapleford church. The vertical axis shows the riverfly score. The horizontal axis shows the month and year the sample was taken. No.1 on the x axis is July 2017. The new channel was opened in December 2017. Sampling started in November 2018.

The Stapleford site has been stable over the last three and a half years with relatively high scores and regular seasonal fluctuations. There have been no pollution scares indicated by no sharp drops to a score of 5 (the trigger level for alerting the EA). The riverfly populations at the Woodhall site have been building over the last couple of years. The river channel has been constructed with a good gravel bed and plenty of riffles ideal for a chalk stream habitat.

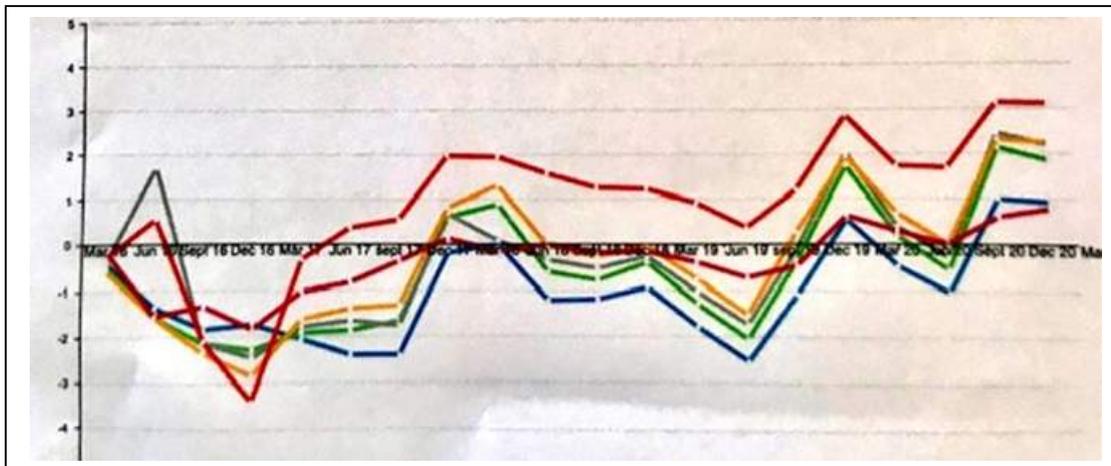
The change in the water table

The chart to the left shows the change in the water table between Walkern and Watton from March 2016 up to December 2020. This is the area covered by the 'cone of depletion' mentioned in a previous article. The

blue line is Walkern, green – Aston End, grey – Aston Ford, yellow – Holdbrook, red – Whitehall and purple is Watton. From this you can clearly see the benefit gained from the reduction in abstraction and the recent wet winters. The river is flowing well along its length despite the dry spring. For example, the depth of the river at Aston Ford, measured during river fly sampling, is currently the deepest since sampling started. The target species are starting to come back to this previously dry stretch with a score of 2 recorded in February and 5 in March.

The Whitehall pumping station used to induce a cone of depletion stretching from south of Walkern down to North of Watton. This includes the stretch of river that has been dry for some years. Analysis of bore hole readings supports the view that the reduction in abstraction since 2017 has resulted in lifting the water table. Several wet winters have also helped and now the river is once again flowing along its full length.

Walkern, which was upstream of the cone, is shown to be unmoved by the change in abstraction. Similarly, Watton, which was down stream of the cone, and the recipient of year round contributions from Stevenage Brook, is also unmoved. Walkern trundles along below all other boreholes and Watton wanders amiably along 'mid-table'.
